[Docket No. 97-CE-67-AD]

#### Airworthiness Directives; Cessna Aircraft Company 300 and 400 Series Airplanes

**ACTION:** Notice of proposed rulemaking (NPRM).

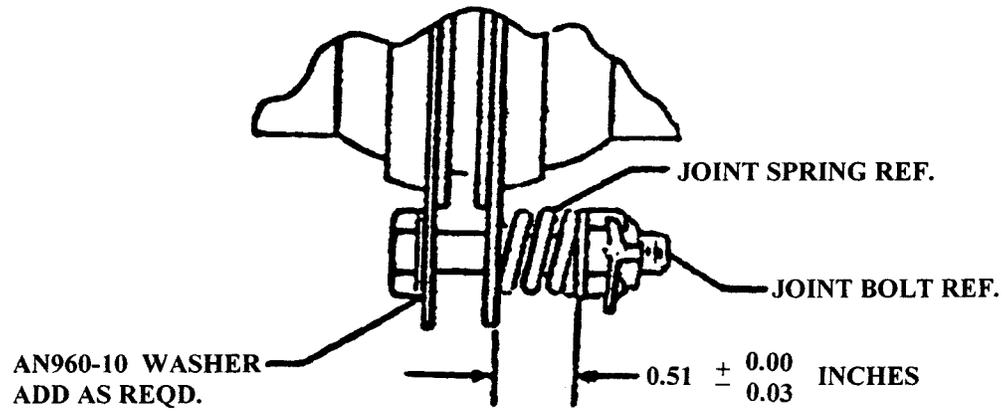
FIGURE 1 to the Appendix

(3) Visually inspect the exhaust joint springs for correct compression. If the joint is disturbed or if the springs are obviously loose or frozen, proceed with the following inspection (see Figure 1 of this Appendix).

(i) Before removal of the exhaust joint springs, measure the installed length of each spring, and replace the springs compressed to less than .45 inch.

(ii) Remove all the springs and measure the free length. Replace any spring having a free length of less than .57 inch.
