[Docket No. 99-SW-80-AD]

Airworthiness Directives; Bell Helicopter Textron Canada Model 206L, L-1, L-3, and L-4 Helicopters

ACTION: Notice of proposed rulemaking (NPRM).

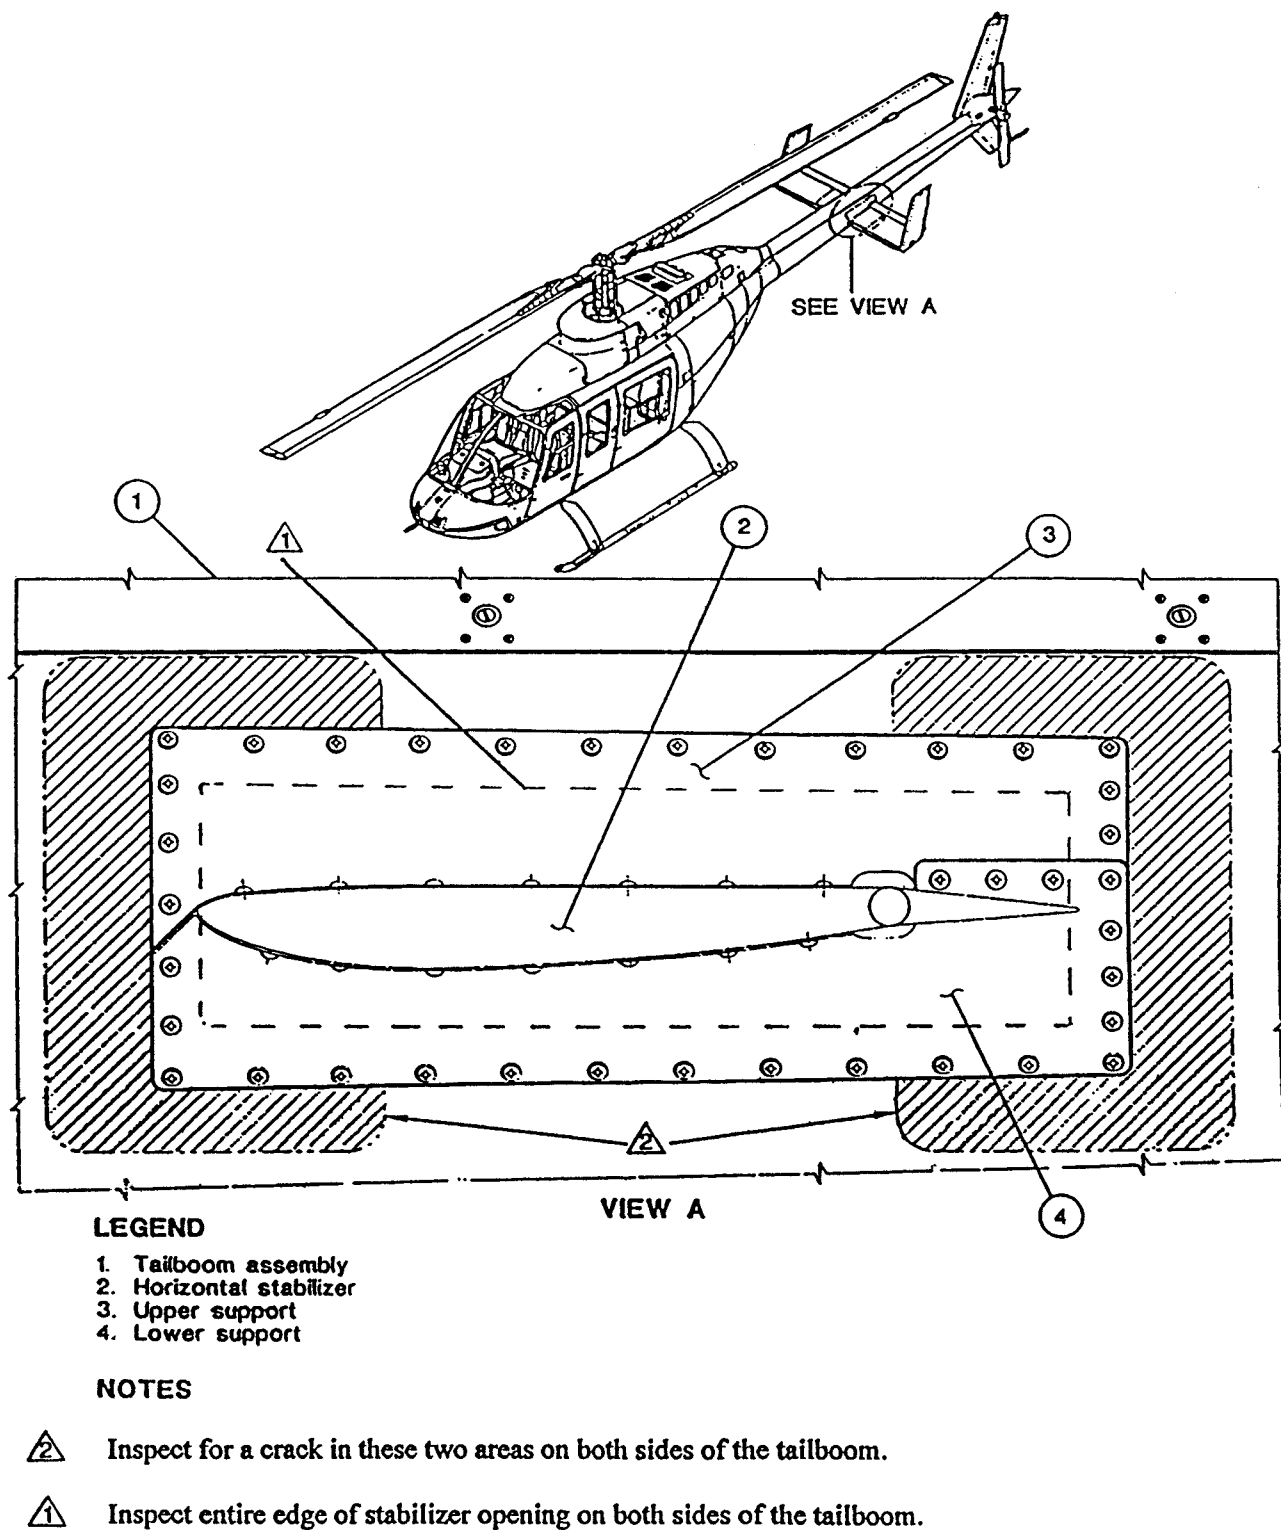
Figure 1

Transport Canada, which is the airworthiness authority for Canada, has notified the FAA that an unsafe condition may exist on BHTC Model 206L, L-1, L-3, and L-4 helicopters. Transport Canada advises that cracks were found on the tailboom skins in the area of the horizontal stabilizer.

(a) Before further flight and thereafter at intervals not to exceed 10 hours time-in-service (TIS) until accomplishing the one-time fluorescent-penetrant inspection (FPI) required by paragraph (c)(2) of this AD, visually inspect for any crack in the shaded areas shown in Figure 1. Use a 10-power or higher magnifying glass. If a crack is found, replace the tailboom with an airworthy

(b) At intervals not to exceed 5 hours TIS, visually check for any crack in the tailboom as depicted by the shaded areas shown in Figure 1. If any crack is found, replace the tailboom with an airworthy tailboom modified according to the requirements of paragraph (e) of this AD before further flight. The visual check may be performed by an owner/operator (pilot) holding at least a private pilot certificate and must be entered into the aircraft records showing compliance with paragraph (b) of this AD in accordance with sections 43.11 and 91.417 (a)(2)(v) of the Federal Aviation Regulations (14 CFR sections 43.11 and 91.417 (a)(2)(v)).

(2) Perform a one-time FPI of the edges of the tailboom skins for any crack around the left and right horizontal stabilizer openings (Figure 1). Remove paint and primer to inspect the edges and exterior skin surface in the skin area at least $\frac{3}{4}$ inch around the edges of the horizontal stabilizer openings.

(3) If a crack is found, replace the tailboom with an airworthy tailboom modified according to the requirements of paragraph (e) of this AD before further flight.

(e) Within the next 300 hours TIS, inspect and modify the tailboom in accordance with Parts I, II, and III of Bell Helicopter Textron Canada (BHTC) Alert Service Bulletin 206L-99-115, Revision D, dated January 26, 2000 (ASB). If a crack is found while accomplishing Part I of the ASB, replace the tailboom with an airworthy tailboom modified as required by this paragraph before further flight. After accomplishing the modification, inspect the modified tailboom at intervals not to exceed 1200 hours TIS in accordance with Part IV of the ASB.
