## DEPARTMENT OF TRANSPORTATION

[Docket No. 2001-SW-50-AD]

**Airworthiness Directives; Eurocopter France Model EC120B, EC155B, SA330F, SA330G, SA330J, AS332C, AS332L, AS332L1, AS332L2, AS350B, AS350BA, AS350B1, AS350B2, AS350B3, AS350D, AS355E, AS355F, AS355F1, AS355F2, AS355N, AS365N2, AS365N3, SA-365N, and SA-365N1 Helicopters**

**ACTION:** Notice of proposed rulemaking (NPRM).

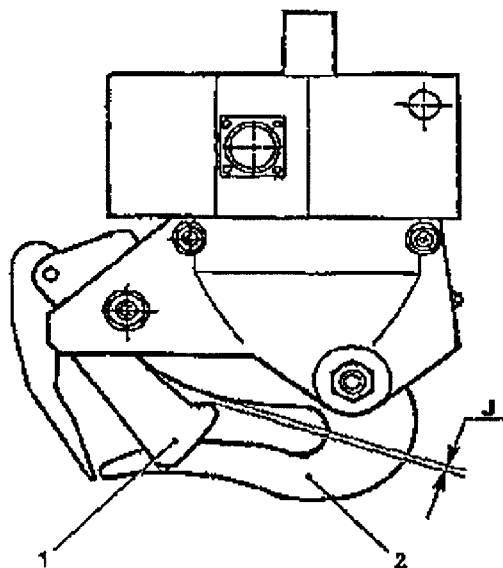
The Direction Generale De L'Aviation Civile (DGAC), the airworthiness authority for France, notified the FAA that an unsafe condition may exist on various ECF model helicopters. The DGAC advises of the discovery of an anomaly on the locking catch of certain cargo hooks that could jam the ring on the cargo hook and jeopardize the release of an underslung load.

This unsafe condition is likely to exist or develop on other helicopters of these same type designs registered in the United States. Therefore, the proposed AD would require, before the next flight utilizing the cargo hook, measuring the clearance between the locking catch and the cargo hook, and removing any cargo hook from service if that clearance is equal to or greater than 14mm (0.55 inches).

Clearance "J" must be less than 14 mm (0.55 inches)

(a) With the cargo hook in the no-load position, measure the clearance "J" in accordance with Figure 1 of this AD. Remove any cargo hook if clearance "J" (see Figure 1) is equal to or greater than 14 millimeters (0.55 inches).
