Airworthiness Directives; Bell Helicopter Textron Canada Model 407 Helicopters

ACTION: Notice of proposed rulemaking (NPRM).

SUMMARY: This document proposes adopting a new airworthiness directive (AD) for Bell Helicopter Textron Canada (BHTC) Model 407 helicopters. This proposal would require visually inspecting the forward hanger bearing bracket (bracket). This proposal is prompted by reports of cracks in the bracket. The actions specified by this proposed AD are intended to detect a crack in the bracket, to prevent loss of tail rotor drive or tail rotor control and subsequent loss of control of the helicopter.

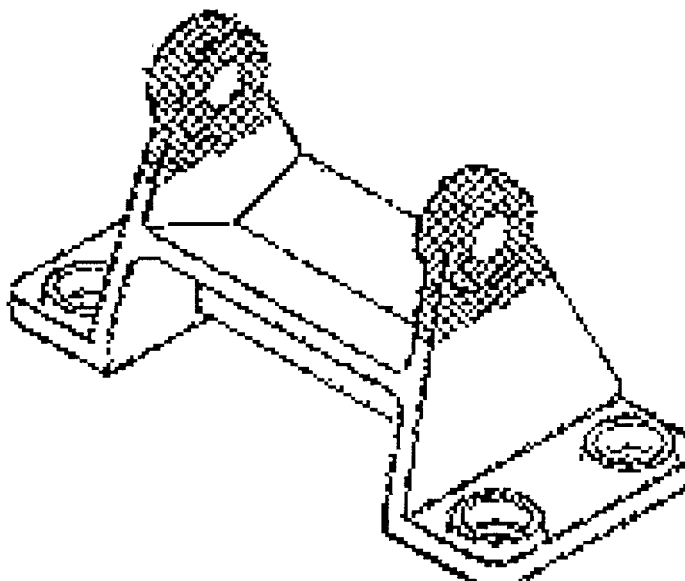
(a) Within 25 hours time-in-service (TIS) and thereafter at intervals not to exceed 25 hours TIS, visually inspect each bracket, P/N 407-040-321-101 or -103, for a crack in the shaded area shown in Figure 1 of this AD. Remove any cracked bracket from service.

Bracket P/N 407-040-321-101/-103
