[Docket No. 2001–SW–74–AD; Amendment 39–12626; AD 2001–26–55]

Airworthiness Directives; Eurocopter France Model AS350B, AS350B1, AS350B2, AS350BA, AS350B3, AS350C, AS350D, AS350D1, AS355E, AS355F, AS355F1, AS355F2, and AS355N Helicopters

2001-26-55 Eurocopter France:

Amendment 39-12626. Docket No. 2001-SW-74-AD.

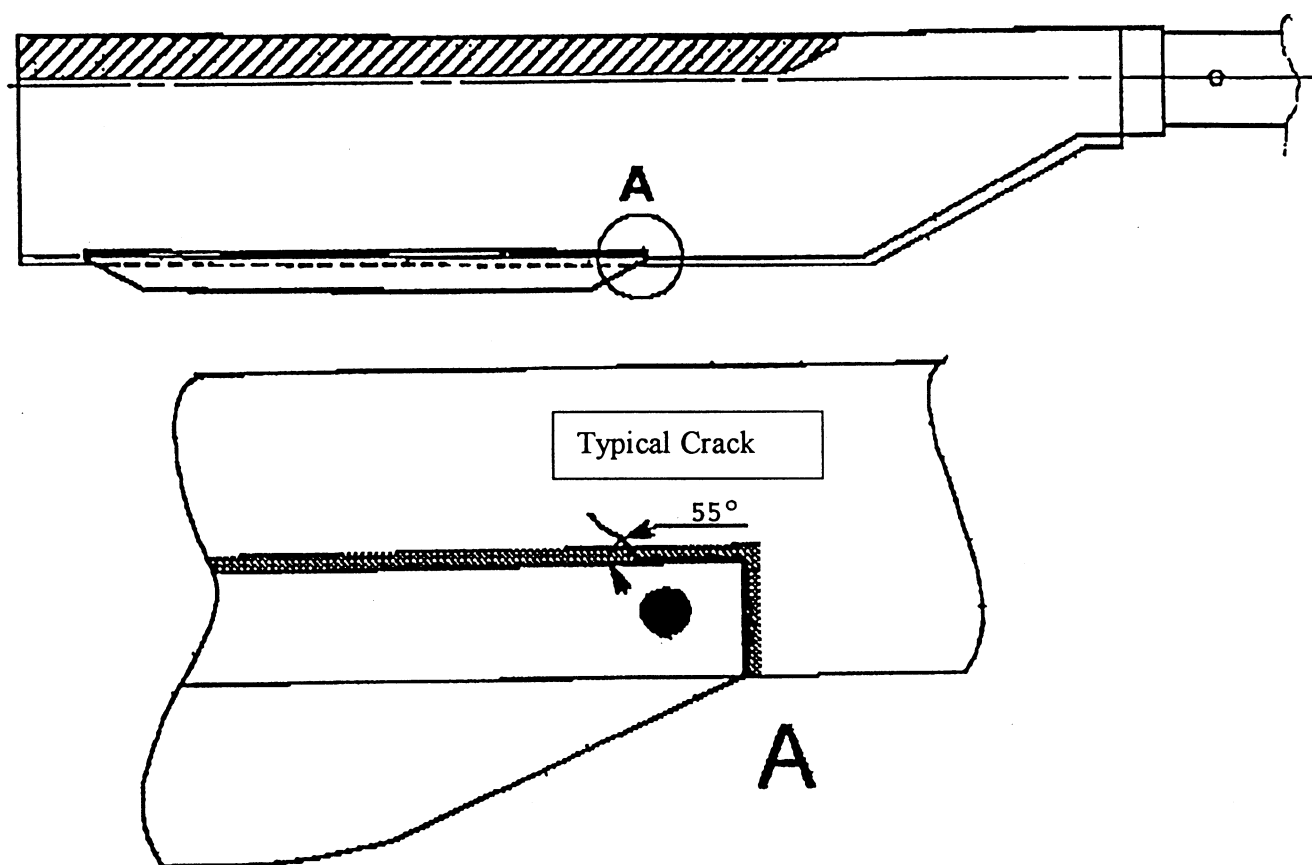
This unsafe condition is likely to exist or develop on other ECF Model AS350B, AS350B1, AS350B2, AS350BA, AS350B3, AS350C, AS350D, AS350D1, AS355E, AS355F, AS355F1, AS355F2, and AS355N helicopters of the same type designs. Therefore, the FAA issued Emergency AD 2001–26–55 to prevent failure of the blade, severe vibration, loss of the TGB, and subsequent loss of control of the helicopter. The AD requires, before further flight and thereafter before the first flight of each day or at intervals not to exceed 10 hours TIS, whichever occurs first, visually checking both sides (front and back) of each blade skin in the area of the trailing edge tab for a crack (see Area A of Figure 1 of this AD). Replacing any cracked blade is also required before further flight.

(a) Before further flight, and thereafter before the first flight of each day or at intervals not to exceed 10 hours time-in-service (TIS), whichever occurs first, visually check both sides (front and back) of each blade skin in the area of the trailing edge tab for a crack as shown in Area A of Figure 1 of this AD.

(c) If in doubt about the existence of a crack in the blade skin, clean the area and then inspect with a 6× or higher magnifying glass.

(d) If a crack is visible in the caulking, remove the caulking with 200-grit abrasive paper, taking care not to sand the skin. Inspect the blade skin for a crack using a 6× or higher magnifying glass.

(e) If a crack is found in the blade skin, replace the blade with an airworthy blade before further flight.
