**DEPARTMENT OF TRANSPORTATION****Federal Aviation Administration****14 CFR Part 39**

**[Docket No. 2001-SW-17-AD; Amendment 39-12657; AD 2002-03-16]**

**Airworthiness Directives; Bell Helicopter Textron, Inc.-Manufactured Model OH-13E, OH-13H, and OH-13S Helicopters**

**2002-03-16 Continental Copters, Inc.; Gifton McCreay (Formerly Aerodyne Systems Engineering, Ltd., Formerly Texas Helicopter Corp.); Hawkeye Rotor and Wing Flight School; and Teryjon Aviation Inc.:** Amendment 39-12657. Docket No. 2001-SW-17-AD. Supersedes AD 2000-18-52, Amendment 39-11984, Docket No. 2000-SW-36-AD.

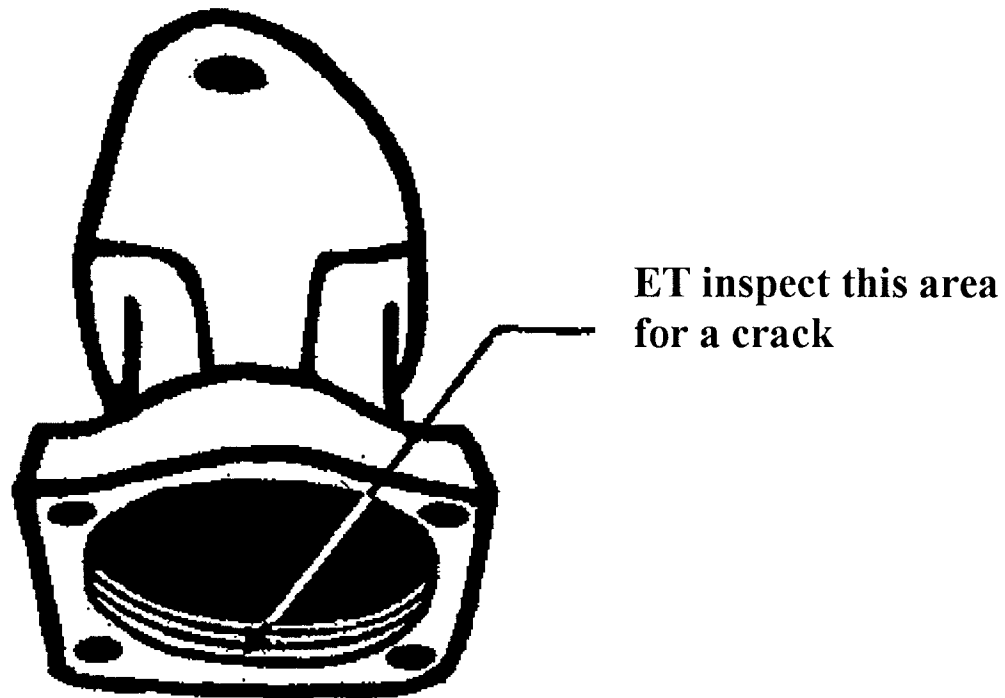
**Figure 1, Appendix 1**

- 1.1 The inboard inside diameter machined threads (reference Figure 1).

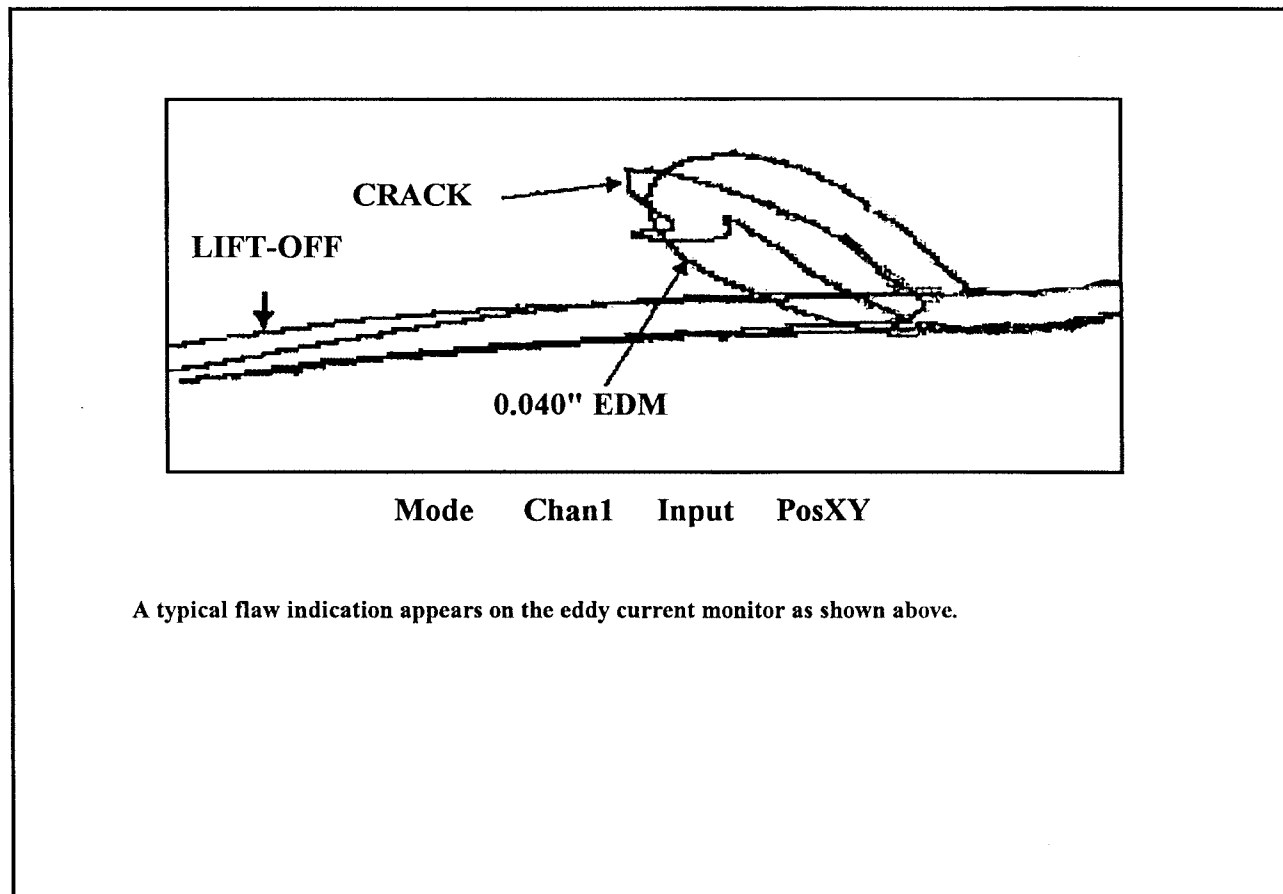
**Figure 2, Appendix 1**

- 6.1 Place the probe into the threaded area and slide it in the same direction as was done on the standard while monitoring the screen for root cracks. Moving the probe in the same direction produces a repeatable display that allows for more accurate flaw size determination. Scan the probe along each individual thread until all the threads are inspected. (See Figures 2 and 3.)

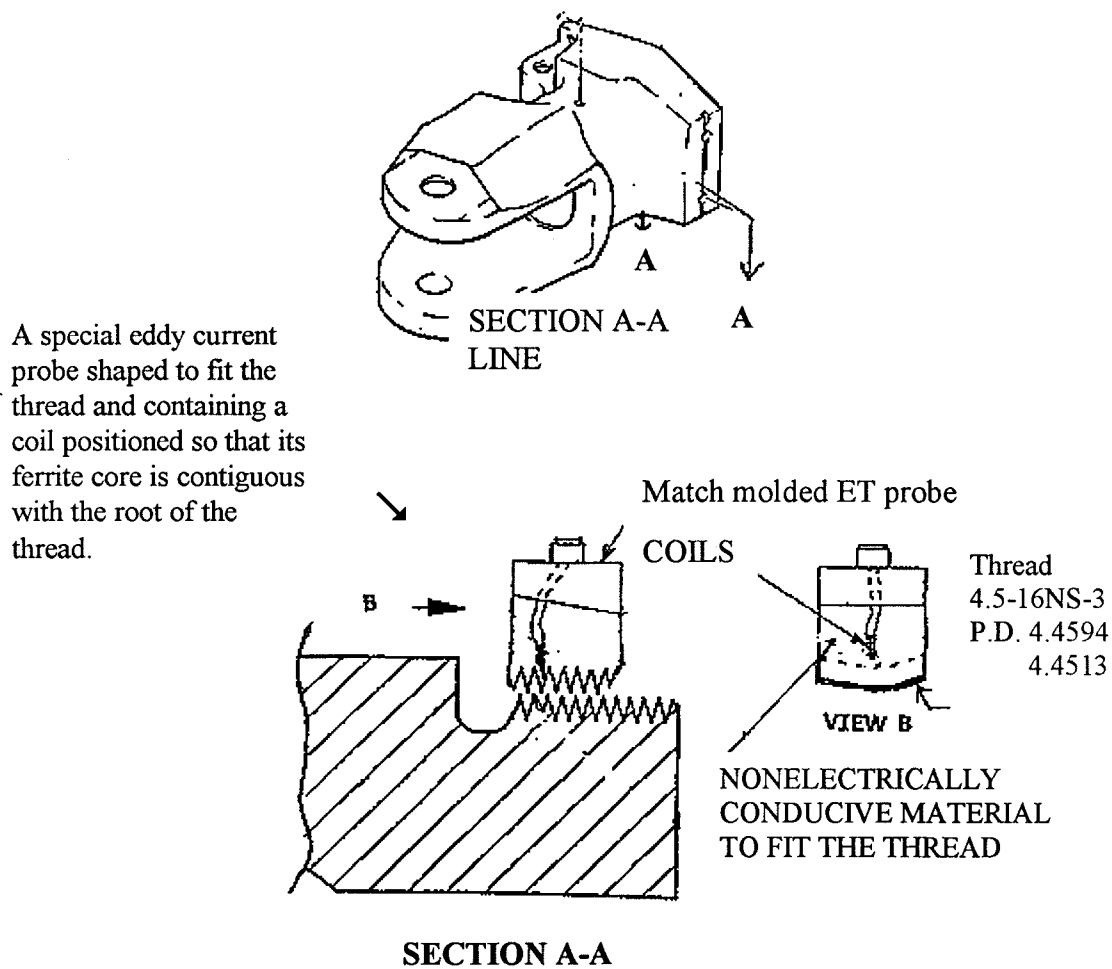
Figure 3, Appendix 1

- 2.1 Zetec Miz-20/22, Phasec 2200 or equivalent piece of equipment.
- 2.2 Match molded ET probe SPC-193 (100kHz) or equivalent. (See Figure 3.)
- 2.3 Reference standard EC-010-021, or equivalent. (See Figures 4 and 5.)
- 2.4 Light oil.

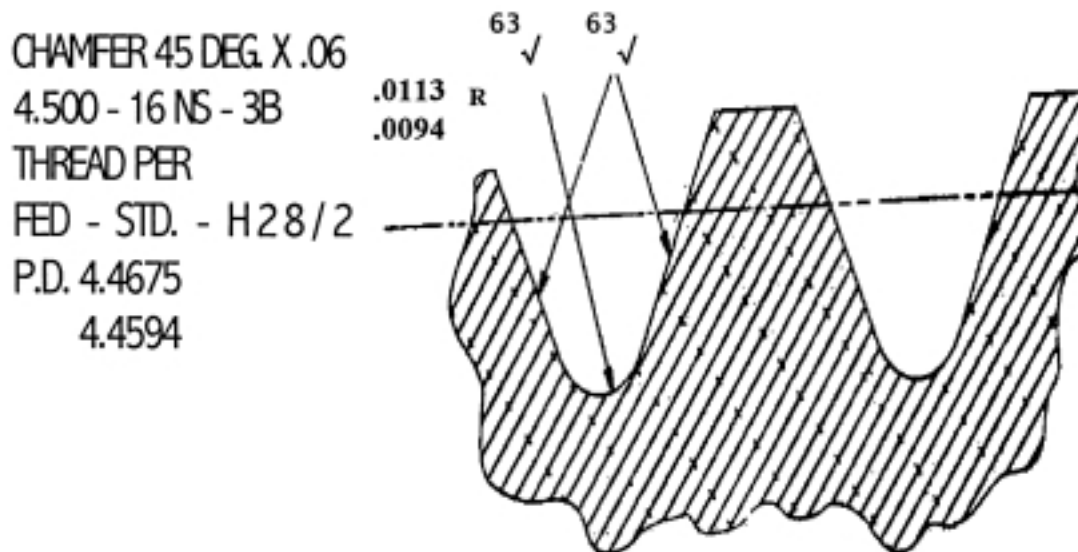
EDM 1 place only in thread root.  
Notch width shall be 0.004 max.  
All other dimensions to be +/- 0.004 from  
indicated.

1. Standard may be machined from aluminum tube stock.
2. The standard shall contain a minimum of four teeth per the tooth dimensions specified.
3. The EDM notch shall be placed in the center most tooth root as measured across the width of the standards. There shall be no less than two teeth and one root on either side of the EDM notch.
