#### **Airworthiness Directives; Eurocopter France Model AS350B, BA, B1, B2, B3, C, D, and D1; EC–130B4; and AS355E, F, F1, F2, and N Helicopters**

**ACTION:** Notice of proposed rulemaking (NPRM).

**Eurocopter France:** Docket No. FAA-2007-27495; Directorate Identifier 2005-SW-14-AD.

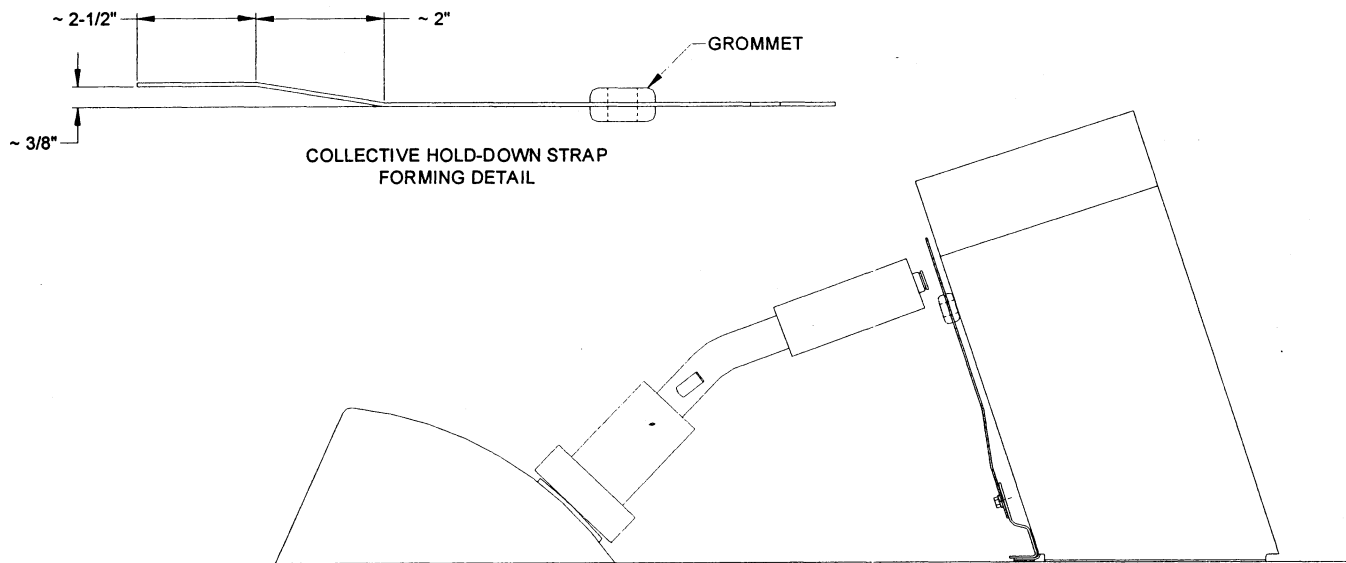
To prevent inadvertent locking of a collective stick in the lowered position during flight and the flight crew not being aware of the locked condition leading to a subsequent loss of control of the helicopter, do the following:

To ensure that the strap does not inadvertently lock the collective during normal operation, the strap must be formed by joggling it as shown in the figure. When formed correctly, the strap will naturally touch the console aft wall, requiring it to be flexed in order to lock the collective.

- (a) Within the next 30 days, unless accomplished previously, modify the strap by forming the strap as depicted in Figure 1 of this AD. Install the modified strap so that the rubber grommet rests against the console. Thereafter, at intervals not to exceed 100 hours time-in-service, inspect the strap to ensure that the rubber grommet is resting against the console.

(b) An alternative approach for complying with paragraph (a) of this AD this AD is to replace the affected strap with an ECF designed strap kit, P/N 350A27-0350-0071, that has a torsional spring at the lower end of the strap. The following Parts List constitutes the required parts of the ECF strap kit designed with the torsional spring at the lower end of the strap:

(c) Replacing the strap with an ECF designed strap kit as described in paragraph (b) of this AD constitutes terminating action for the requirements of this AD.
