[Docket No. FAA-2005-22696; Directorate Identifier 2005-SW-22-AD; Amendment 39-14877; AD 2007-01-06]

Airworthiness Directives; Bell Helicopter Textron Canada Model 206A, B, L, L-1, L-3, and L-4 Helicopters

2007–01–06 Bell Helicopter Textron Canada:

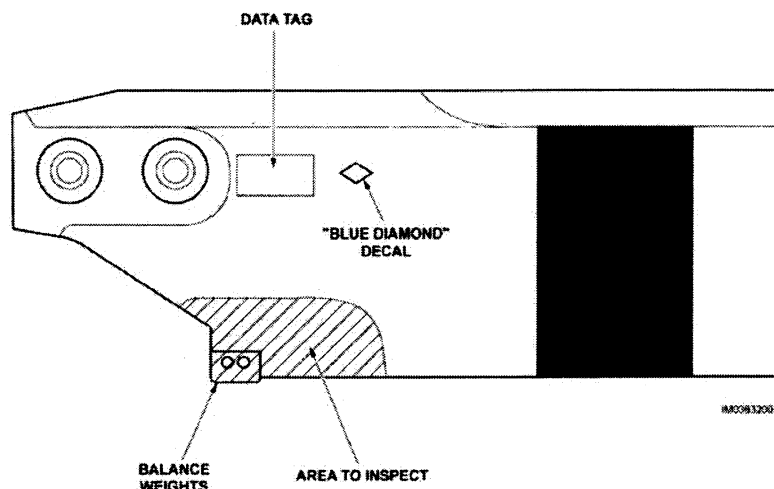
Figure 1. Tail rotor blade inspection.

Transport Canada, the airworthiness authority for Canada, notified the FAA that an unsafe condition may exist on these helicopter models. Transport Canada advises of three reports of skin cracks originating near the blade trailing

edge balance weight. Two of the occurrences caused a loss of the weight and a strip of material along the trailing edge leading to an imbalance, which caused the fracture of three of the four tail rotor gearbox attachments. One of these occurrences resulted in the gearbox shifting that caused failure of the drive shaft and resulting loss of yaw control. Transport Canada issued AD No. CF-2004-05R1, dated June 28, 2004, to ensure the continued airworthiness of these helicopters in Canada.

blade for a deformation, a crack, and a bent or deformed weight in the area shown in Figure 1 of this AD.

Note 1: Paint irregularities on the blade may indicate a crack.

(1) At intervals not to exceed 12 hours time-in-service (TIS), using a 10X or higher magnifying glass, inspect both sides of each blade for a deformation, a crack, and a bent or deformed weight in the area shown in Figure 1 of this AD, or

(2) Inspect and check both sides of each blade for a deformation, a crack, and a bent or deformed weight in the area shown in Figure 1 of this AD as follows:

(c) Before further flight, replace any blade that has a deformation, a crack, or a bent or deformed weight with an airworthy blade.
