[Docket No. FAA-2013-0822; Directorate Identifier 2013-SW-004-AD; Amendment 39-17783; AD 2014-05-10]

Airworthiness Directives; Airbus Helicopters (Type Certificate Previously Held by Eurocopter France) (Airbus Helicopters)

2014–05–10 Airbus Helicopters (Type Certificate Previously Held By Eurocopter France): Amendment 39–17783; Docket No. FAA–2013–0822; Directorate Identifier 2013–SW–004–AD.

This AD defines the unsafe condition as severe vibrations due to failure of laminated half-bearings (bearings). This condition could result in failure of the tail rotor and subsequent loss of control of the helicopter.

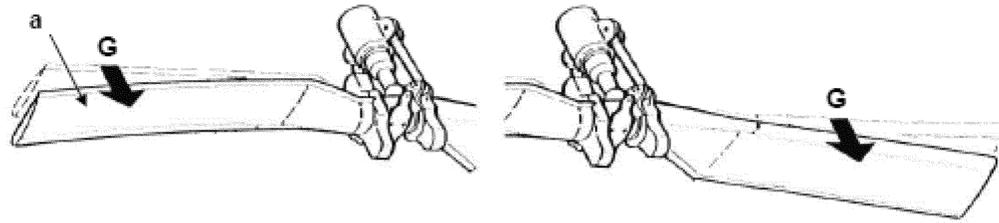
(E) Apply load (G) by hand perpendicular to the suction face of one tail rotor blade as shown in Figure 5 to paragraph (f) of this AD.

(F) While maintaining the load, check visible faces of Area C as shown in Figure 5 to paragraph (f) of this AD for any extrusion. A flashlight may be used to enhance the check.

(v) If there is an extrusion on any bearing, before further flight, replace the four bearings with airworthy bearings.
