[Docket No. FAA–2015–8463; Directorate Identifier 2014–NM–226–AD]

Airworthiness Directives; Airbus Airplanes

ACTION: Notice of proposed rulemaking (NPRM).

SUMMARY: We propose to supersede Airworthiness Directive (AD) 2013–20–11, for all Airbus Model A318, A319, A320, and A321 series airplanes. AD

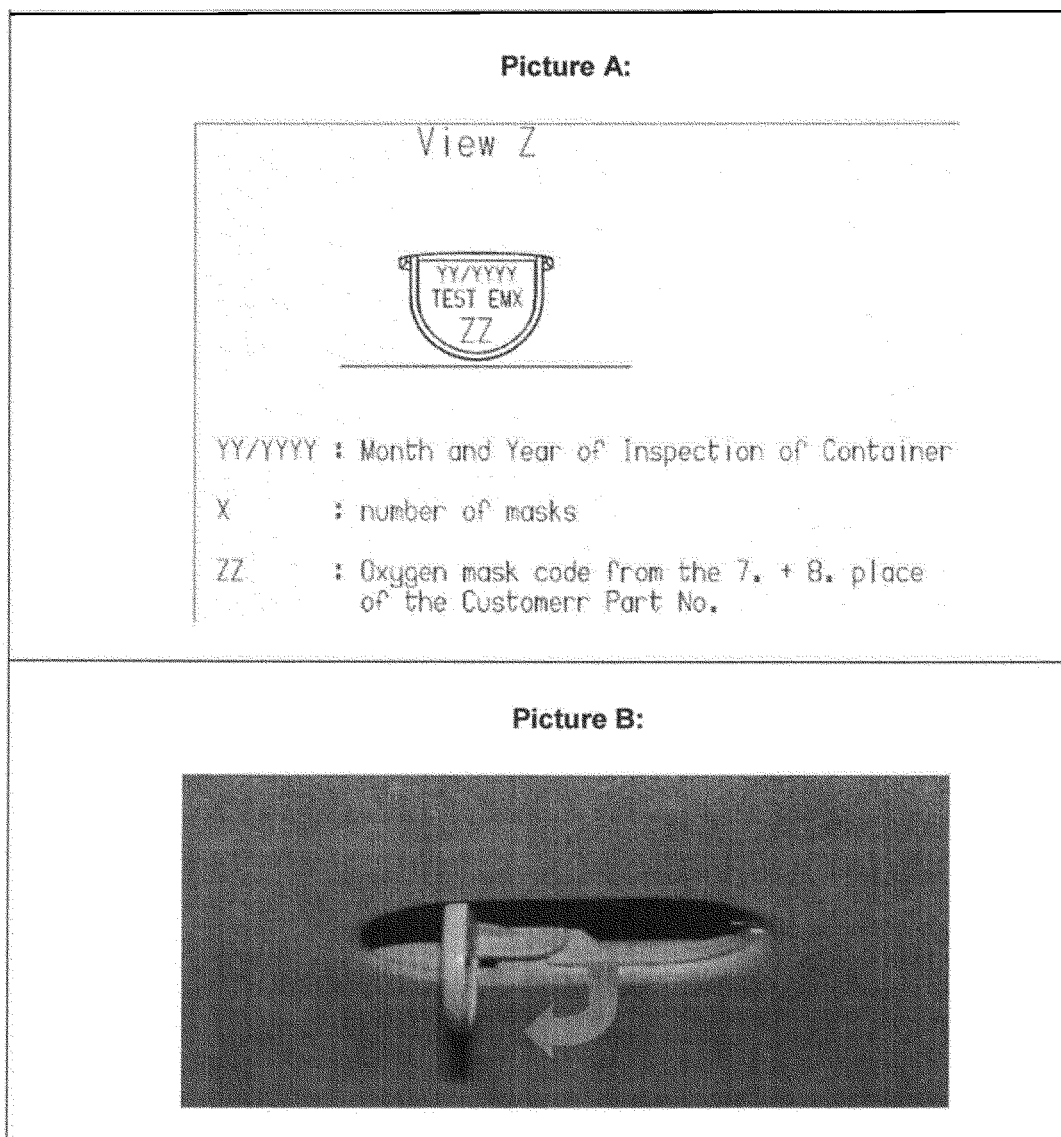
Figure 1 to Paragraph (l)(4) of this AD – Design A of the Passenger Oxygen Containers

Note 2 to paragraph (l)(4) of this AD: For "Design A," the placard on the passenger oxygen container test button is as described in "Picture A" in figure 1 to paragraph (l)(4) of this AD. The mask configuration ("ZZ" in "Picture A") is a number, and the test button is as shown in "Picture B."
